DEPARTMENT OF VETERANS AFFAIRS
OFFICE OF INSPECTOR GENERAL

Review of Allegations of
Improper Maintenance at
VA's Houston National
Cemetery in Texas

REPORT #21-03325-86

MARCH 10, 2022

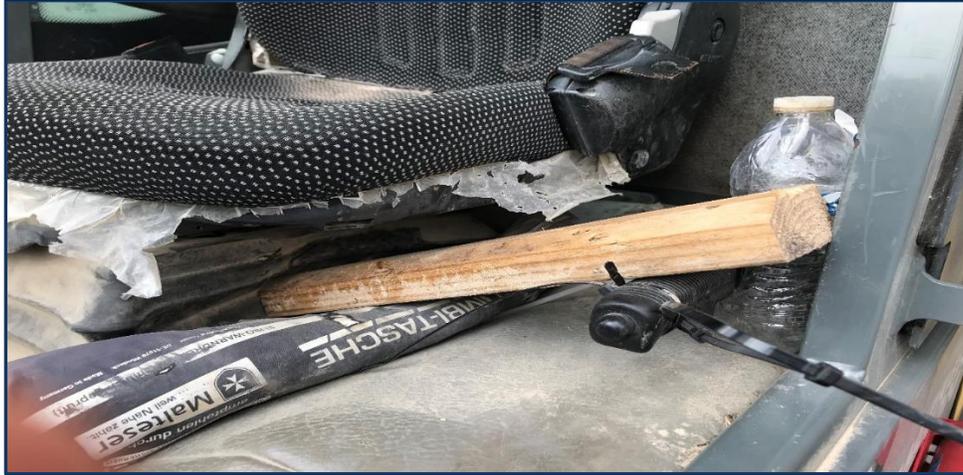
maintained.¹⁰ For example, cemetery staff wedged a piece of wood into the front loader's emergency brake; the front loader also had fluid leaks and windshield wipers that did not provide visibility. Figure 2 shows the defective emergency brake in the front loader.

*Figure 2. Defective emergency brake in a front loader at the Houston National Cemetery.
Source: VA OIG staff.*

Additionally, one flatbed vehicle had an emergency brake that did not consistently operate, and two had lift gates (tailgates) that did not stay latched. The other 16 pieces of motorized equipment were operational.

The review team brought the condition of the front loader and flatbeds to the attention of the mechanic during their site visit. In response to the inquiry, the front loader was moved to the maintenance area for repair. The mechanic was able to repair the windshield wipers but was unable to repair the emergency brake and the fluid leak. After receiving funding and approval, the front loader was sent to the dealer for repair on October 4, 2021.

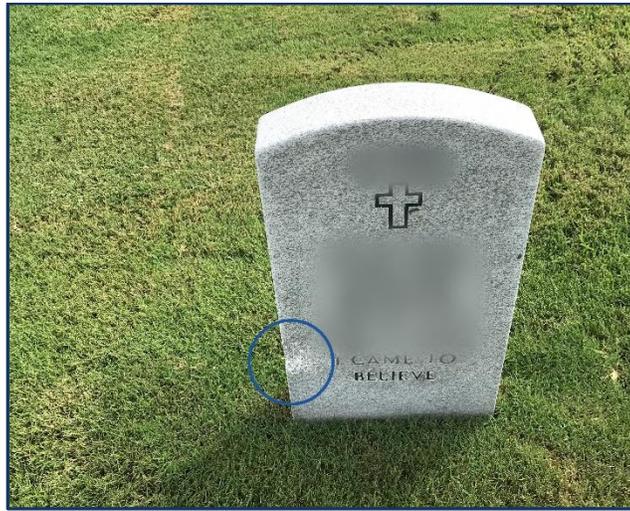
- Six headstones were damaged (chipped, broken, stained, or soiled).
- Eight headstones were not aligned.
- 23 gravesites had dried-out sod or were overgrown with weeds.

Figure 3 shows a damaged headstone, and figure 4 shows a gravesite with dried-out sod.

Figure 3. Chipped headstone (the blue circle shows the damaged area).
Source: VA OIG staff.

To address recommendation 2, the Houston National Cemetery director stated that as of October 25, 2021, contractors were able to resod gravesites identified by the OIG review team. The director addressed headstone issues and determined that four headstones needed to be replaced. In addition, the cemetery director stated the OIG provided a list of 63 deficiencies that appeared to include six duplicate gravesites.

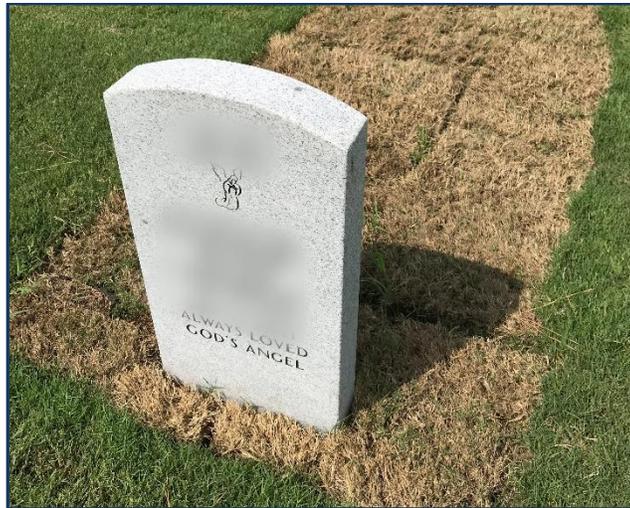
Figure 4. Gravesite with dried-out sod and weeds. The veteran was buried on May 11, 2021, and the photograph was taken on September 2, 2021.
Source: VA OIG staff.
